**Flood Control Project Maintenance
Levee Inspections**
LMA District Cover Sheet
Spring 2019 Levee Inspection Results

Reclamation District No. 1001 Nicolaus

Spring 2019 Levee Inspection Results

Waterway	Bank	Unit Miles
Unit No. 01 Yankee Slough	Right	4.12

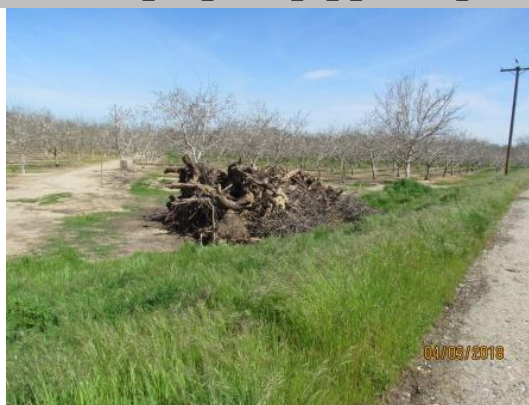
Photo 1 of 1 : SP_2019_RD1001_36_7_20190305_00005.jpg

This photo was taken of the landside looking upstream at prunings stacked up at the levee toe.

LM Start	1.53	Rating **	M	Issue No.	28	
LM End	1.53	Issue Type +	En	Location *		
Category	Supplemental			GPS Latitude/Longitude		
				Start	End	
Item	DWR UCIP Field Study			38.970622 °	38.970622 °	
				-121.494171 °	-121.494171 °	
DWR ID	22526					
Comment Code						
Inspector Comment						
FS_ID:42016						
DS_ID:22526						
EP_NO: N/A						
Repair Type: Non-Urgent						
Crossing Status: Not Found						
UCIP Comments: 05/22/2013 Dense vegetation should be removed.						
(P. Amatya - DWR UCIP)						
FIELD_STRUCT_DESC: 36-inch standpipe and service pole at the						
landside (LS) toe. [Additional Reference(s): DWR Levee Log, 1993].						
FS Date: 5/22/2013

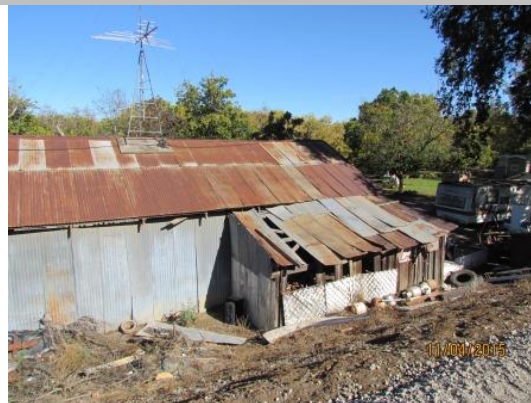
Photo 1 of 1 : SP_2019_RD1001_36_8_20190305_00006.jpg

View of the shed at the landside levee toe.

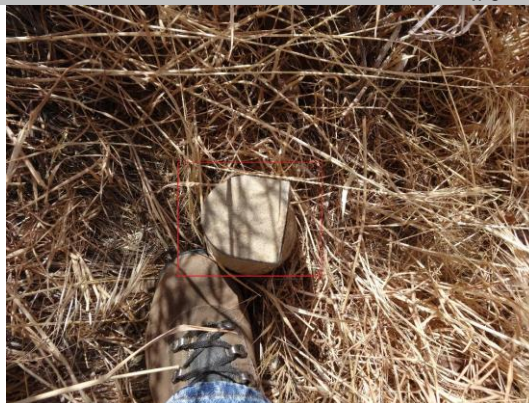
Photo 3 of 3 : UCIP_SP_2019_41673_22743.jpg

Comment Code						
Inspector Comment						
FS_ID:41673 DS_ID:22536 EP_NO: 5562 Repair Type: Non-Urgent Crossing Status: Found UCIP Comments: 05/23/2013 Pipe appears abandoned and if so should be done so properly. WS pipe plugged with stopper. Seems abandoned. Only abandoned pump base found. (P. Amatya - DWR UCIP) FIELD_STRUCT_DESC: 6-inch coated steel irrigation pipe through the levee, 3.5 feet below the crown. Metal cutoff collar placed on the pipe at the center of the levee crown. Pump was removed. Pump base on the waterside (WS) berm. Shutoff valve on the discharge side of the pump. Foot valve below water on the intake side of the pump. Siphon breaker on the landside (LS) shoulder. Pipe discharges into underground irrigation system on the LS. Power pole and meter box, 10 feet from the landward toe. 1.5-inch flexible conduit through levee, 3.5 feet below the crown. (Pump and 6-inch irrigation pipe authorized under Permit No. 5562, 1966 - Samuel B. Single). [Additional Reference(s): DWR Levee Log, 1993]. FS Date: 5/23/2013

LS- only pipe air vent found on levee slope.

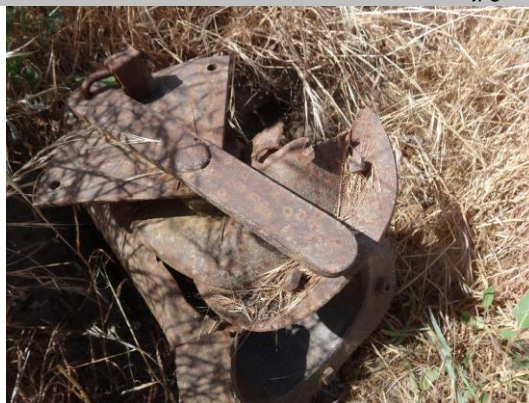
Photo 2 of 3 : UCIP_SP_2019_50740_22752.jpg

Comment Code					
Inspector Comment					
FS_ID:50740 DS_ID:22529 EP_NO: 2281 Repair Type: Non-Urgent Crossing Status: Not Found UCIP Comments: 01/17/2019 Records detailing the actions taken for the removal of the 7-inch pipe were recorded under file name LI10703_79259 document 20141008 CVFPB letter of acknowledgement available through permit records. (O. Magana - DWR UCIP) 07/13/2016 According to district president Joe Henderson, pipe was removed 2-3 years ago. No permit for removal found or evidence of pipe or its removal found. (K. Fazel - UCIP) 05/23/2013:- leaky pipe end and erosion on WS.- cracked dirt mound on LS - seems not been used for some time. (P. Amatya - DWR) FIELD_STRUCT_DESC: *REMOVED* 7-inch steel irrigation pipe through the levee, 1.9 feet below the crown. Portable pump mounted on the bank during the summer months. Control valve on the waterside (WS). Steel plate bolted on the WS end during the winter months. Pipe discharges into a 30-inch concrete standpipe at the landside (LS) toe. (Pump and 7-inch irrigation pipe authorized under Permit No. 2281, 1956 - Willard R. Brown; 7-inch pipe through levee and concrete standpipe located on LS were removed as part of the 2013 USACE Periodic Inspection). [Additional Reference(s): DWR Levee Log, 1993]. FS Date: 7/13/2016

WS- seems abandoned or not been used for some time.

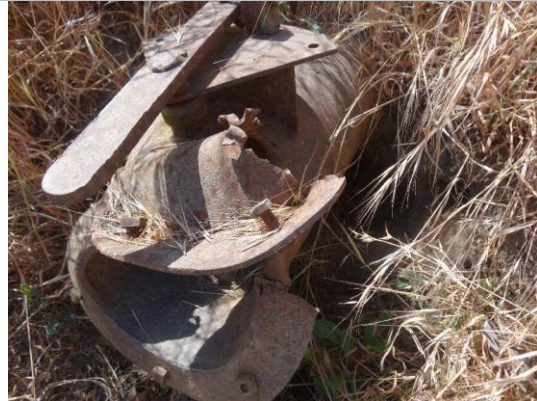
Photo 3 of 3 : UCIP_SP_2019_50740_22751.jpg

Comment Code						
Inspector Comment						
FS_ID:50740 DS_ID:22529 EP_NO: 2281 Repair Type: Non-Urgent Crossing Status: Not Found UCIP Comments: 01/17/2019 Records detailing the actions taken for the removal of the 7-inch pipe were recorded under file name LI10703_79259 document 20141008 CVFPB letter of acknowledgement available through permit records. (O. Magana - DWR UCIP) 07/13/2016 According to district president Joe Henderson, pipe was removed 2-3 years ago. No permit for removal found or evidence of pipe or its removal found. (K. Fazel - UCIP) 05/23/2013:- leaky pipe end and erosion on WS.- cracked dirt mound on LS - seems not been used for some time. (P. Amaty - DWR) FIELD_STRUCT_DESC: *REMOVED* 7-inch steel irrigation pipe through the levee, 1.9 feet below the crown. Portable pump mounted on the bank during the summer months. Control valve on the waterside (WS). Steel plate bolted on the WS end during the winter months. Pipe discharges into a 30-inch concrete standpipe at the landside (LS) toe. (Pump and 7-inch irrigation pipe authorized under Permit No. 2281, 1956 - Willard R. Brown; 7-inch pipe through levee and concrete standpipe located on LS were removed as part of the 2013 USACE Periodic Inspection). [Additional Reference(s): DWR Levee Log, 1993]. FS Date: 7/13/2016

WS- due to water leak, soil around pipe eroded.

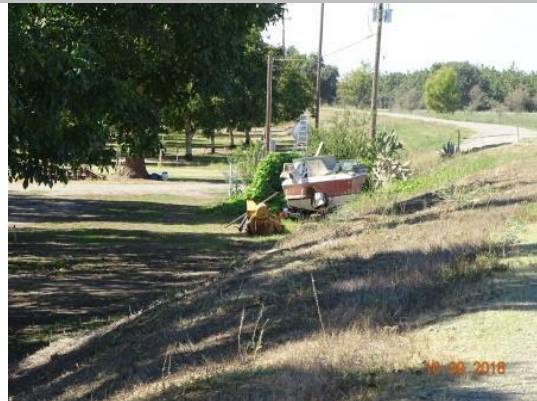
Photo 1 of 2 : SP_2019_RD1001_35_19_20190305_00009.jpg

View of a boat at the landside levee toe. Fall 2018.

LM Start	0.53	Rating **	M	Issue No.	19
LM End	0.53	Issue Type +	En	Location *	LS
Category	Earthen Levee			GPS Latitude/Longitude	
				Start	End
Item	Encroachments			38.974371 °	38.974371 °
				-121.481223 °	-121.481223 °
DWR ID	DWR_RD1001_02_f_2016_19				
Comment Code					
AV : Abandoned vehicles					
Inspector Comment					
Remove boat parked at the landside levee toe, Fall 2018.

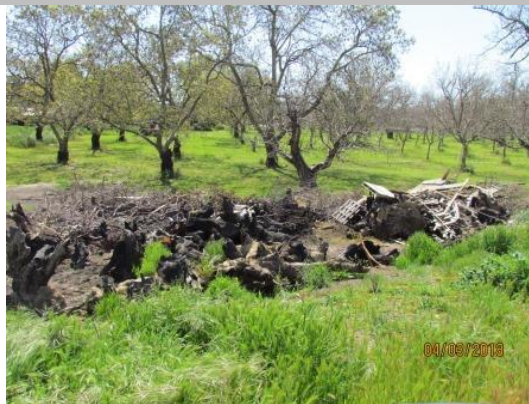
Photo 1 of 1 : SP_2019_RD1001_35_29_20190305_00016.jpg

View looking downstream landside at prunings and stumps that need to be removed from levee toe.

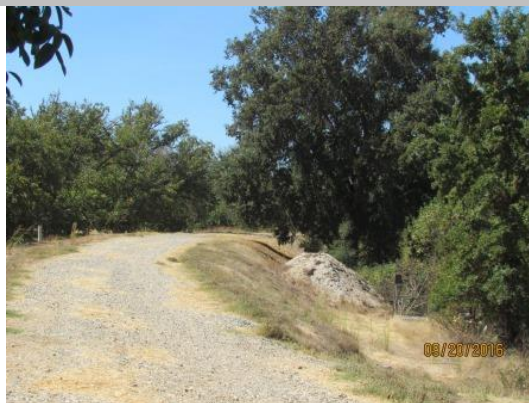
Photo 1 of 1 : SP_2019_RD1001_35_12_20190305_00005.jpg

View of a pile of soil on the waterside slope looking downstream.

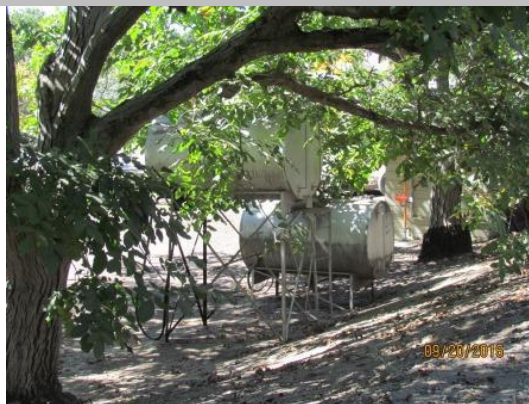
Photo 1 of 1 : SP_2019_RD1001_35_23_20190305_00013.jpg

View of two tanks that are at the landside levee toe.

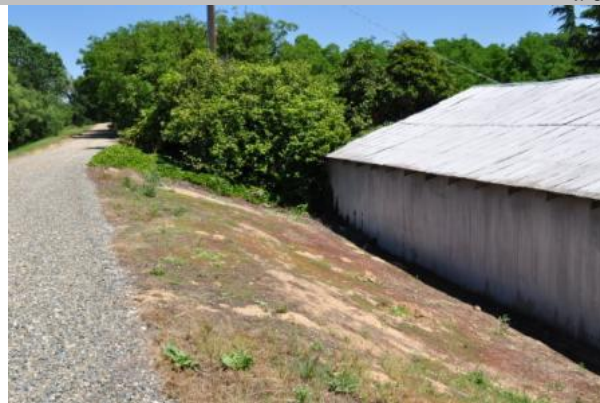
Photo 1 of 1 : SP_2019_RD1001_35_11_20190305_00004.jpg

RD 1001 Unit 2 - L/S -Building @ toe.

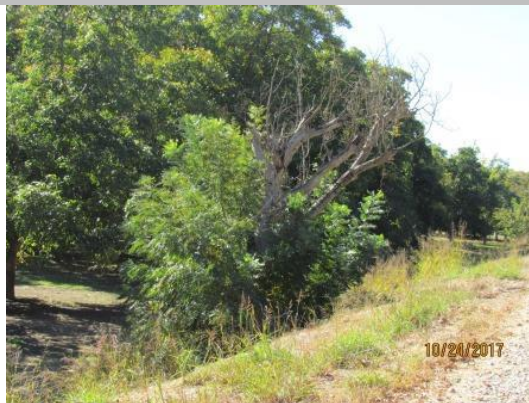
Photo 1 of 1 : SP_2019_RD1001_35_5_20190305_00001.jpg

View looking downstream landside at a large stump that needs to be removed.

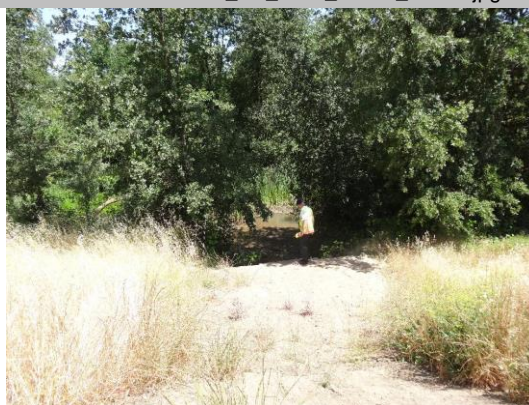
Photo 1 of 3 : UCIP_SP_2019_14008_23108.jpg

LM Start	2.28	Rating **	M	Issue No.	55
LM End	2.28	Issue Type +	Ma	Location *	
Category	Supplemental			GPS Latitude/Longitude	
				Start	End
Item	DWR UCIP LMA Responsibility			38.967403 °	38.967403 °
				-121.510953 °	-121.510953 °
DWR ID	22543				
Comment Code					
Inspector Comment					
FS_ID:14008 DS_ID:22543 EP_NO: N/A Repair Type: Non-Urgent Crossing Status: Found UCIP Comments: 05/23/2013 - slide gate in inlet pipe on landside - pits on pipe due to corrosion (P. Amatya - DWR UCIP) FIELD_STRUCT_DESC: 36-inch corrugated metal gravity drainage pipe through the levee, 15 feet below the crown. Flap gate and concrete U-shaped headwall at outfall on the waterside (WS) end. Slide gate at inlet on the landside (LS) end. (Reclamation District No. 1001). [Additional Reference(s): DWR Levee Log, 1993. USACE Sacramento O&M Manual 141.1, August 1955, (Station 67+75)]. FS Date: 5/23/2013

WS- overview of waterside of the levee.

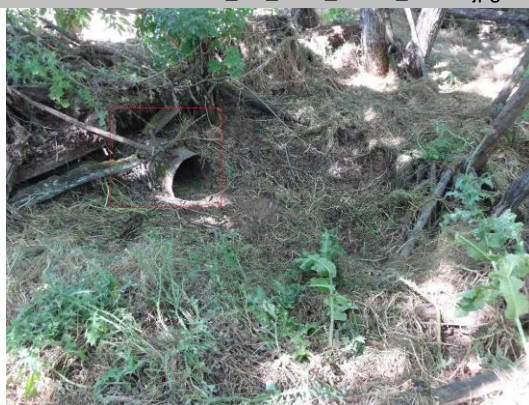
Photo 1 of 3 : UCIP_SP_2019_14128_23308.jpg

LM Start	0.88	Rating **	M	Issue No.	911
LM End	0.88	Issue Type +	En	Location *	
Category	Supplemental			GPS Latitude/Longitude	
				Start	End
Item	DWR UCIP Field Study			39.006508 °	39.006508 °
				-121.391086 °	-121.391086 °
DWR ID	22549				
Comment Code					
Inspector Comment					
FS_ID:14128 DS_ID:22549 EP_NO: 958 Repair Type: Non-Urgent Crossing Status: Found UCIP Comments: 05/21/2013 - slide gate on WS not found- needs abandoned properly. (P. Amatya - DWR UCIP) FIELD_STRUCT_DESC: *ABANDONED* 24-inch irrigation pipe of an unknown material through the levee, at an unknown depth. Slide gate on the waterside (WS) end. (24-inch irrigation pipe authorized under Permit No. 958, 1944 - Frank B. Lichty and Maggie Lichty). FS Date: 5/21/2013

WS- abandoned CMP on berm of the levee.

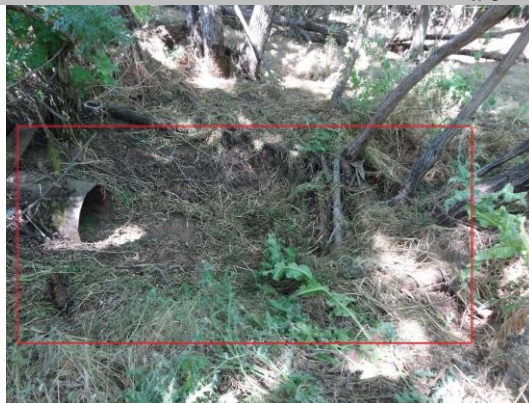
Photo 2 of 3 : UCIP_SP_2019_14128_23307.jpg

LM Start	0.88	Rating **	M	Issue No.	911 (cont)	
LM End	0.88	Issue Type +	En	Location *		
Category	Supplemental			GPS Latitude/Longitude		
				Start	End	
Item	DWR UCIP Field Study			39.006508 °	39.006508 °	
				-121.391086 °	-121.391086 °	
DWR ID	22549					
Comment Code						
Inspector Comment						
FS_ID:14128						
DS_ID:22549						
EP_NO: 958						
Repair Type: Non-Urgent						
Crossing Status: Found						
UCIP Comments: 05/21/2013 - slide gate on WS not found- needs abandoned properly. (P. Amatya - DWR UCIP)						
FIELD_STRUCT_DESC: *ABANDONED* 24-inch irrigation pipe of an unknown material through the levee, at an unknown depth. Slide gate on the waterside (WS) end. (24-inch irrigation pipe authorized under Permit No. 958, 1944 - Frank B. Lichty and Maggie Lichty).						
FS Date: 5/21/2013

WS- abandoned CMP and depression around it.

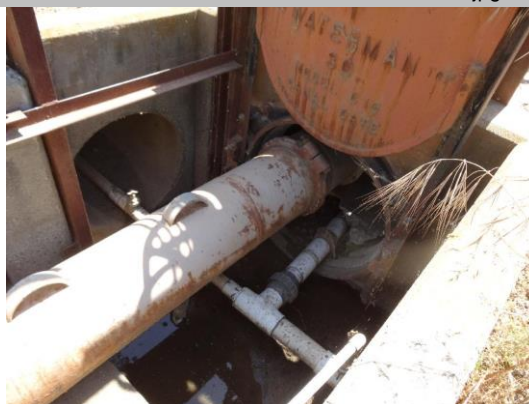
Photo 3 of 3 : UCIP_SP_2019_41727_23323.jpg

Comment Code						
Inspector Comment						
FS_ID:41727 DS_ID:22561 EP_NO: 4505 Repair Type: Non-Urgent Crossing Status: Found UCIP Comments: 05/21/2013 Two small steel pipes sleeved through 30-inch CMP may be a compliance issue as slidegate cannot close.- this may have been converted into drainage pipe (?) - big CMP standpipe on WS. (P. Amatya - DWR UCIP) FIELD_STRUCT_DESC: 30-inch concrete encased corrugated metal irrigation pipe through the levee, 11 feet below the crown. Concrete headwall and slide gate at the waterside (WS) toe, removed. Metal walkway on the WS to the slide gate. Pipe discharges into a 48-inch concrete standpipe at the landside (LS) toe. Two vertical pumps. (30-inch concrete encased corrugated metal irrigation pipe authorized under Permit No. 4505, 1964 - State of California, Department of Public Works, Division of Highways). [Additional Reference(s): DWR Levee Log, 1993. USACE Sacramento O&M Manual 141.1, August 1955, (Station 949+00), 30-inch steel pipe referenced]. FS Date: 5/21/2013

WS- two steel pipes are sleeved through 30-inch CMP.

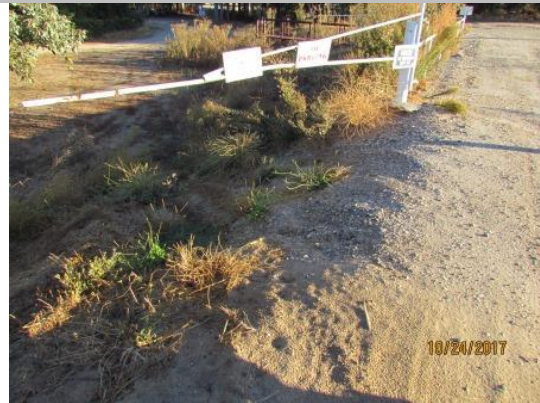
Photo 1 of 1 : SP_2019_RD1001_37_28_20190305_00018.jpg

Continual damage to waterside slope caused by vehicles.

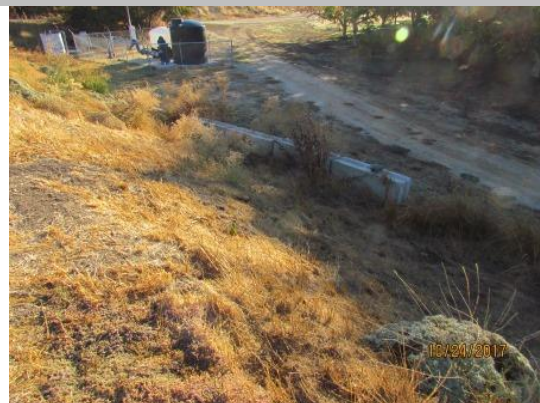
Photo 1 of 1 : SP_2019_RD1001_37_29_20190305_00019.jpg

Continual damage caused by vehicles going around the gate.

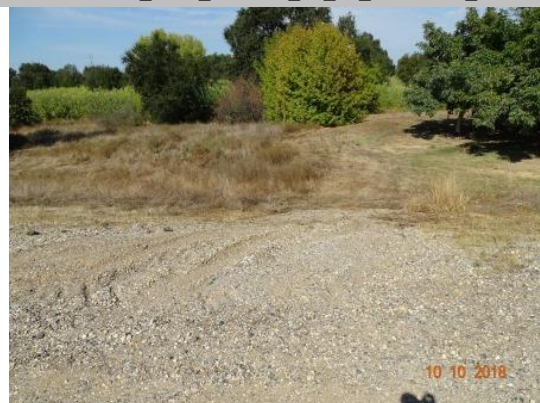
Photo 1 of 1 : SP_2019_RD1001_37_30_20190305_00020.jpg

View looking at waterside where slope has been disturbed by vehicle traffic, Fall 2018.

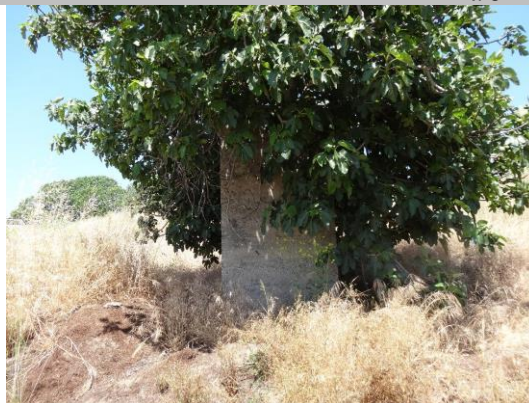
Photo 2 of 2 : UCIP_SP_2019_41722_23337.jpg

LS- a big tree inside concrete standpipe.

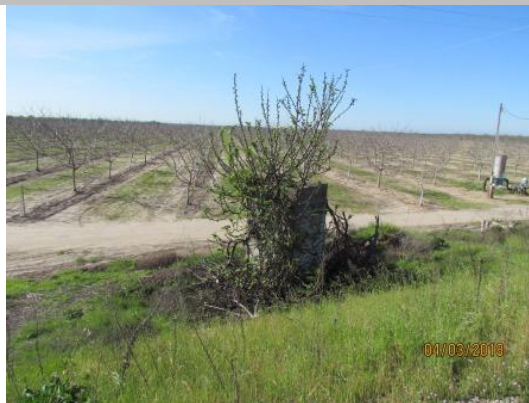
Photo 1 of 1 : SP_2019_RD1001_37_36_20190305_00024.jpg

View of a small starter tree on landside slope looking downstream that is less than 4" in diameter.

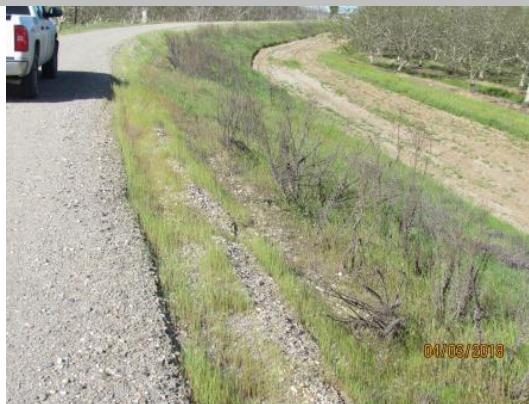
Photo 1 of 1 : SP_2019_RD1001_37_21_20190305_00014.jpg

Erosion on waterside slope still remains as of Spring 2019.

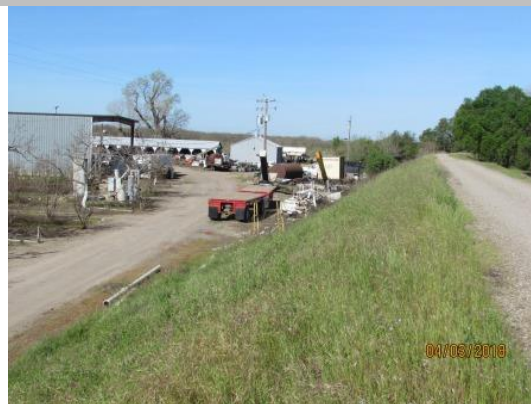
Photo 1 of 2 : SP_2019_RD1001_37_7_20190305_00003.jpg

Irrigation pipe equipment and plastic cans within the easement of the levee.

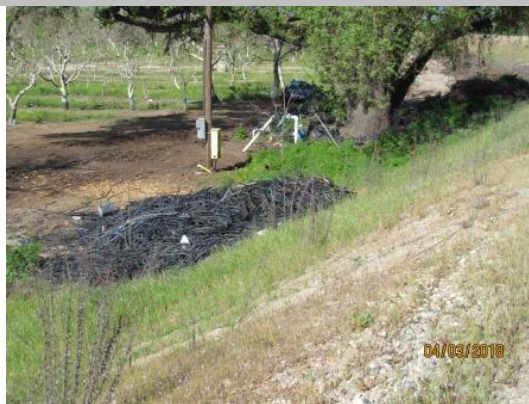
Photo 1 of 2 : SP_2019_RD1001_37_26_20190305_00016.jpg

View of the same drip irrigation and trash on levee slope.

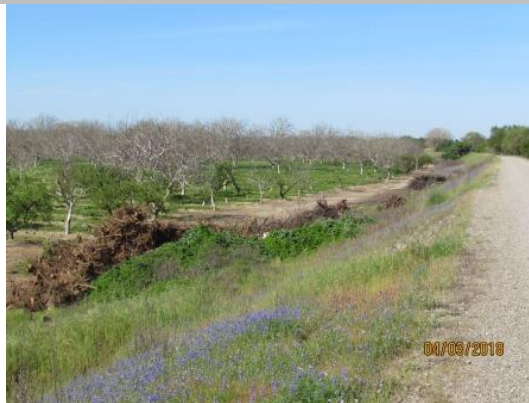
Photo 2 of 2 : SP_2019_RD1001_37_33_20190305_00022.jpg

View looking downstream landside of the same prunings on levee slope from Fall 2017 to Spring 2018.

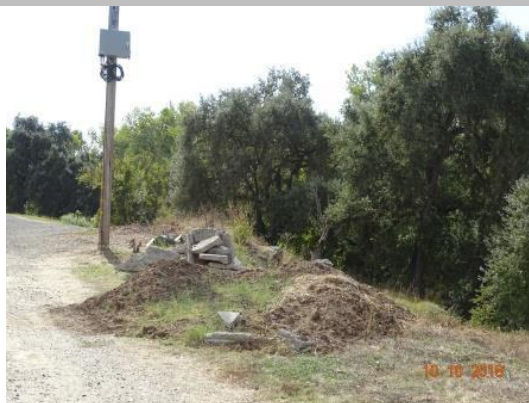
Photo 1 of 1 : SP_2019_RD1001_37_37_20190305_00025.jpg

View looking downstream waterside crown of debris that needs to be removed, Fall 2018.

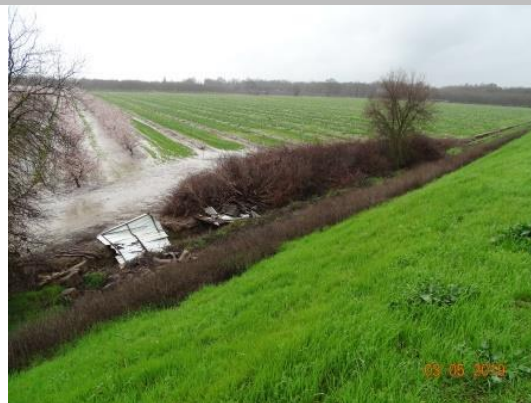
Photo 1 of 1 : SP_2019_RD1001_37_14_20190320_00036.jpg

View looking downstream landside at debris that has been piled up on the levee toe, Spring 2019.

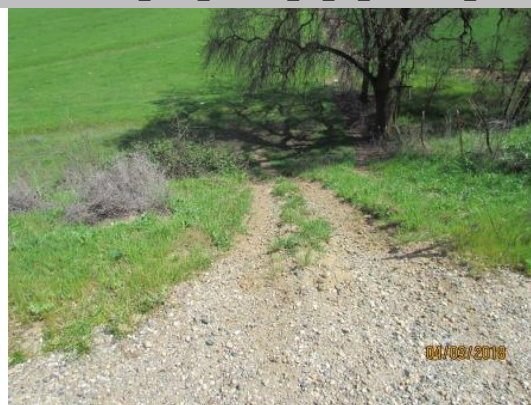
Photo 1 of 1 : SP_2019_RD1001_38_68_20190305_00038.jpg

View of ruts caused by vehicle on the landside levee slope.

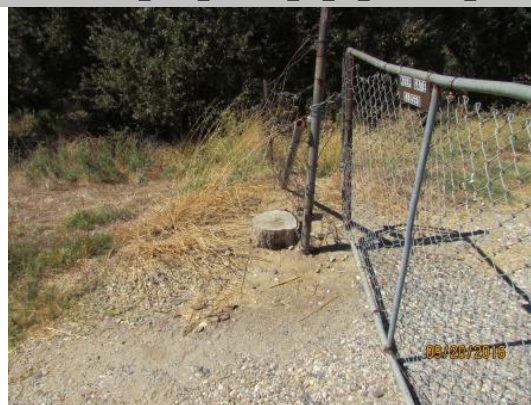
Photo 1 of 1 : SP_2019_RD1001_38_60_20190305_00031.jpg

View of tree stump, waterside crown at gate.

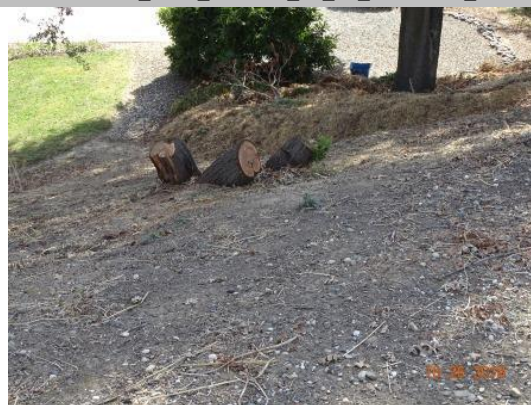
Photo 1 of 1 : SP_2019_RD1001_38_71_20190305_00041.jpg

View looking landside at stumps from a fallen and removed tree, Fall 2018.

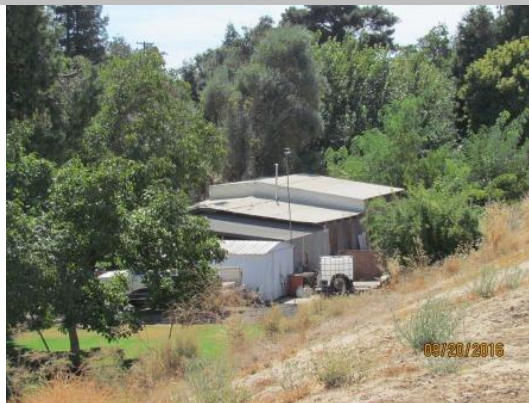
Photo 1 of 1 : SP_2019_RD1001_38_20_20190305_00009.jpg

View of buildings along the toe within the easement of the landside levee.

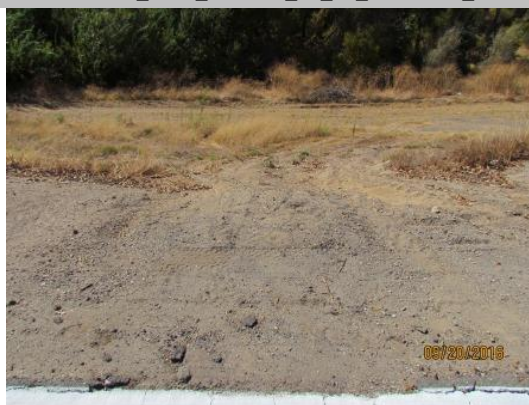
Photo 1 of 1 : SP_2019_RD1001_38_78_20190305_00042.jpg

Ruts still there on waterside slope due to vehicles.

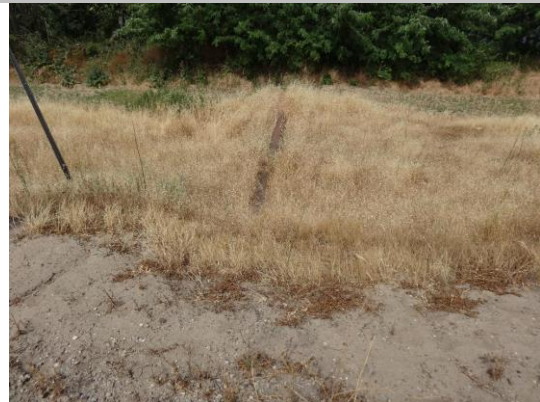
Photo 1 of 3 : UCIP_SP_2019_14544_23966.jpg

WS- damaged pipe with holes, cracks on levee slope. River bank is not visible due to dense vegetation (top)

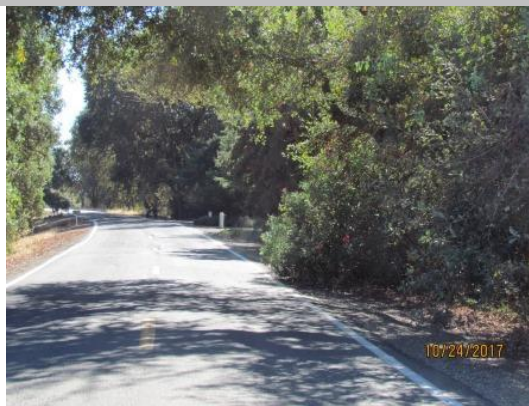
Photo 1 of 1 : SP_2019_RD1001_38_37_20190305_00022.jpg

View looking downstream waterside of landscaping vegetation encroaching onto the levee crown.

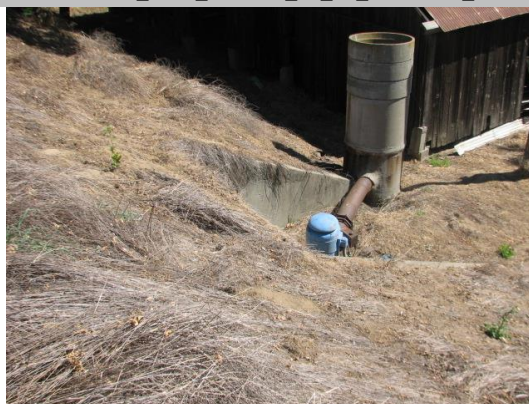
Photo 1 of 1 : SP_2019_RD1001_38_30_20190305_00015.jpg

A retaining wall is within the profile of the slope.

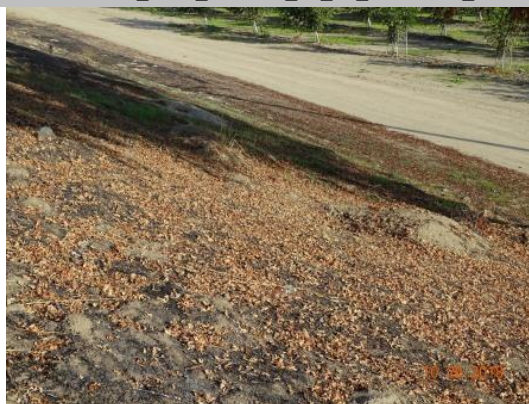
Photo 1 of 1 : SP_2019_RD1001_38_56_20190305_00029.jpg

View of landside levee slope of rodent holes that need to be properly backfilled, Fall 2018.

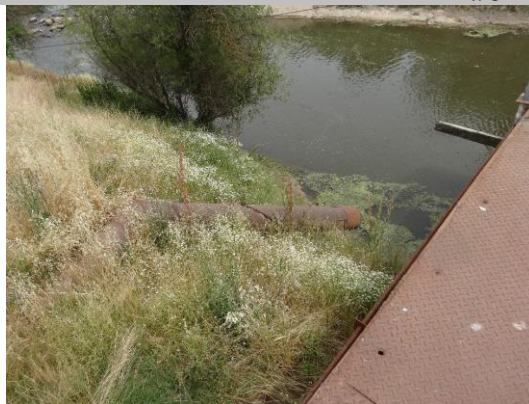
Photo 2 of 3 : UCIP_SP_2019_14486_23912.jpg

WS- abandoned pipe adjacent to pump station on stream bank.

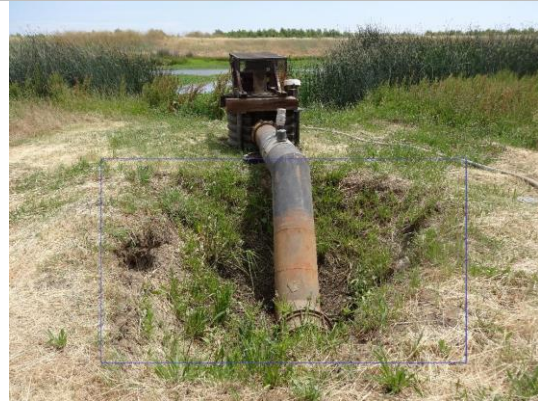
Photo 1 of 3 : UCIP_SP_2019_53424_23429.jpg

WS- large depression on levee berm

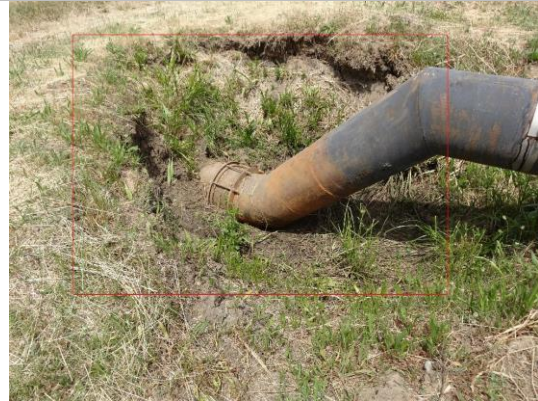
Photo 3 of 3 : UCIP_SP_2019_53424_23426.jpg

WS- large depression on levee berm at pipe daylight

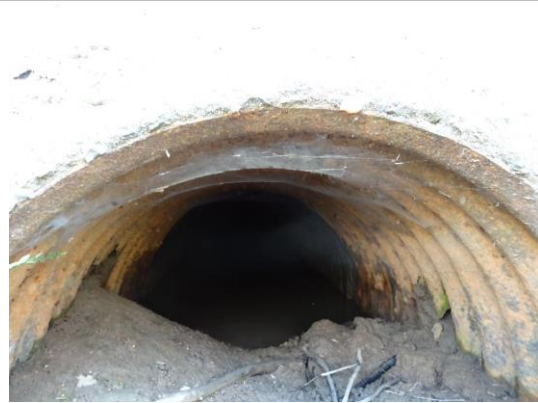
Photo 3 of 3 : UCIP_SP_2019_53425_22044.jpg

LS- highly corroded and damaged CMP in concrete head/wing wall outlet

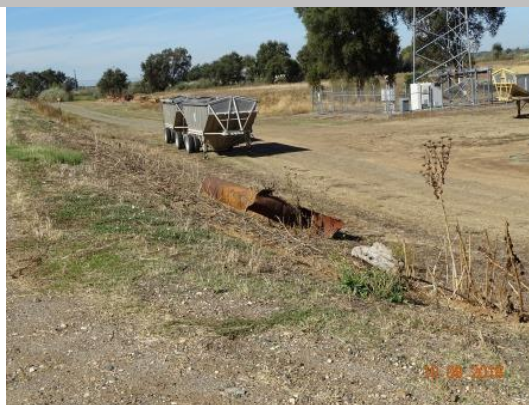
Photo 2 of 2 : SP_2019_RD1001_40_24_20190305_00009.jpg

View of an old piece of pipe still lying on landside levee slope looking downstream. Fall 2018.
